# FLOOD INTELLIGENCE IN MANAGING FLOODPLAIN A WIMMERA PROSPECT

A Aziz<sup>1</sup>, P Fennell<sup>1</sup>, G Fletcher<sup>1</sup>, T Baker<sup>1</sup>

<sup>1</sup>Wimmera Catchment Management Authority  
24 Darlot Street, Horsham, Victoria  
Email: aziza@wcma.vic.gov.au

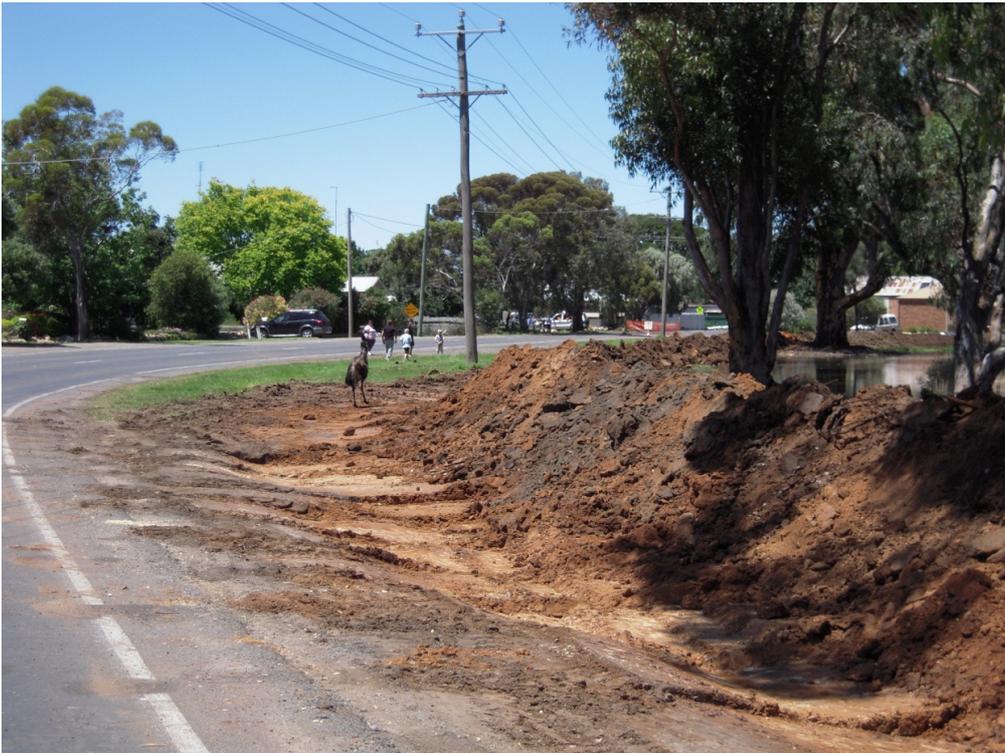
**Figure 4: Informal embankment along Yarriambiack Creek in Warracknabeal. Note it has artificially raised the water level on the right-hand side.**

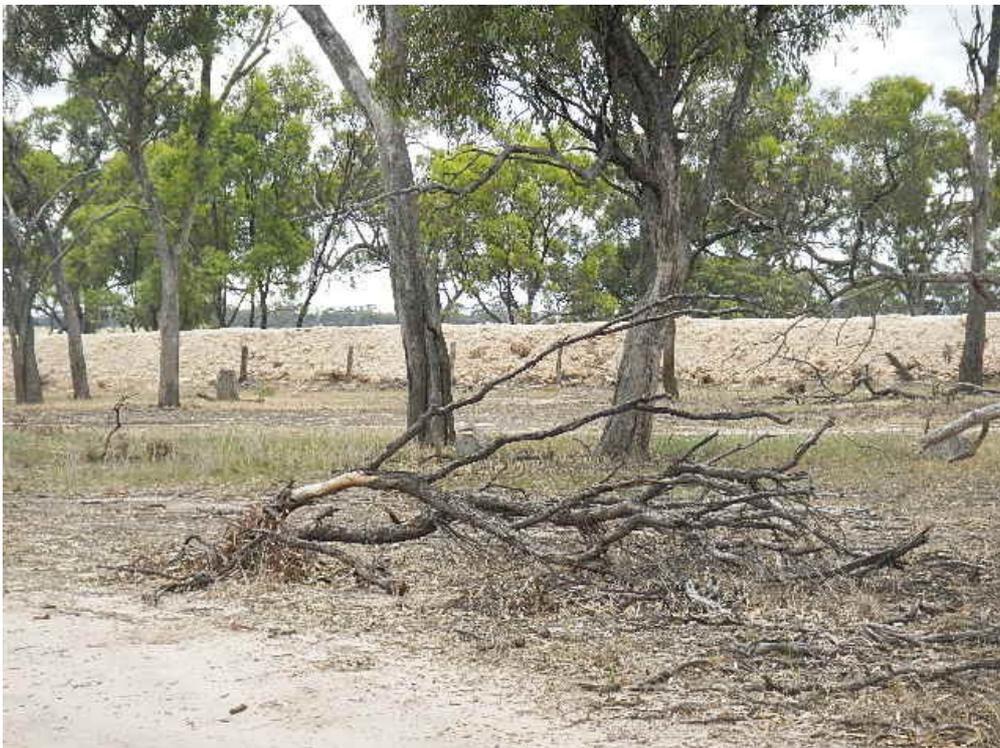
**Figure 5: This illegal levee was constructed after the January 2011 flood to protect agricultural land.**

After two major floods in September 2010 and January 2011, landholders, are concerned about future flooding impacts which is leading to the construction of illegal informal levees that will increase flooding in adjacent areas.

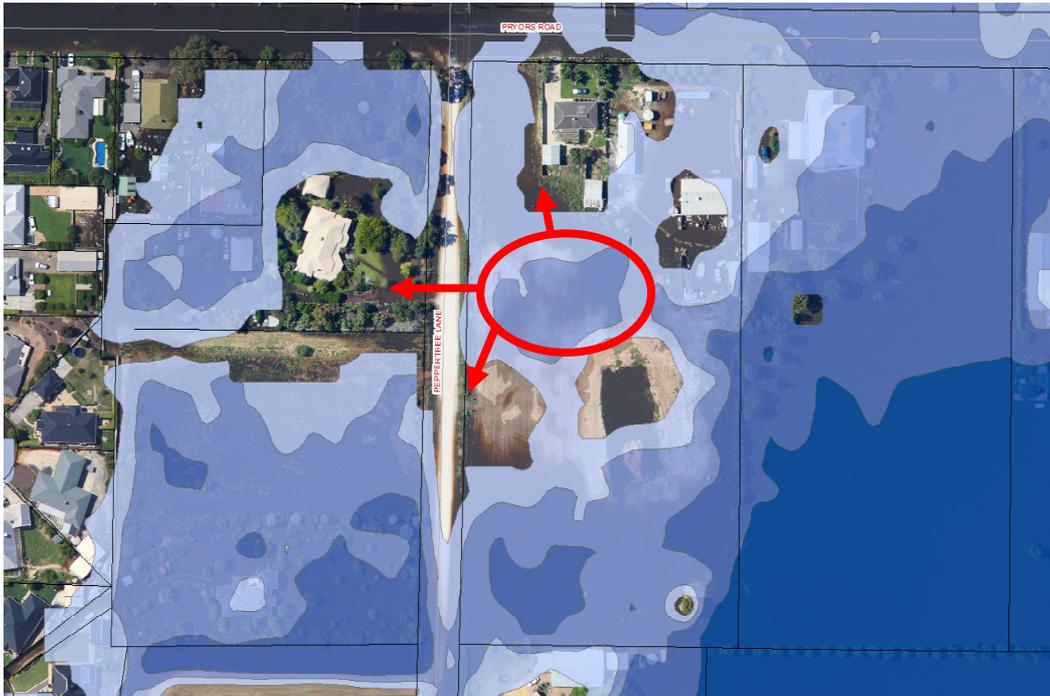
**Figure 6: Aerial Photo overlapping with 100 years ARI mapping shows illegal filling on properties and the impact of reduced flood storage in the adjacent areas and properties.**

Wimmera CMA is also working with councils to reverse irresponsible illegal land filling, especially within urban areas which reduces flood storage and intelligence, causing potential threats to the adjacent properties within the floodplain.

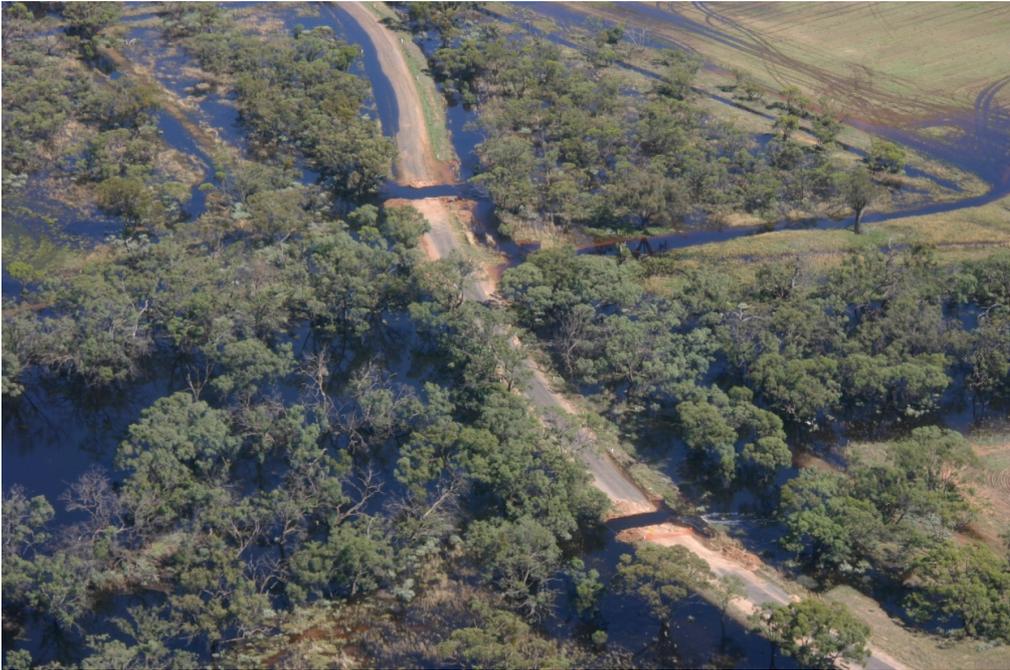
**Figure 7: Road cut-out crossing Yarriambiack Creek during January 2011 flood.**

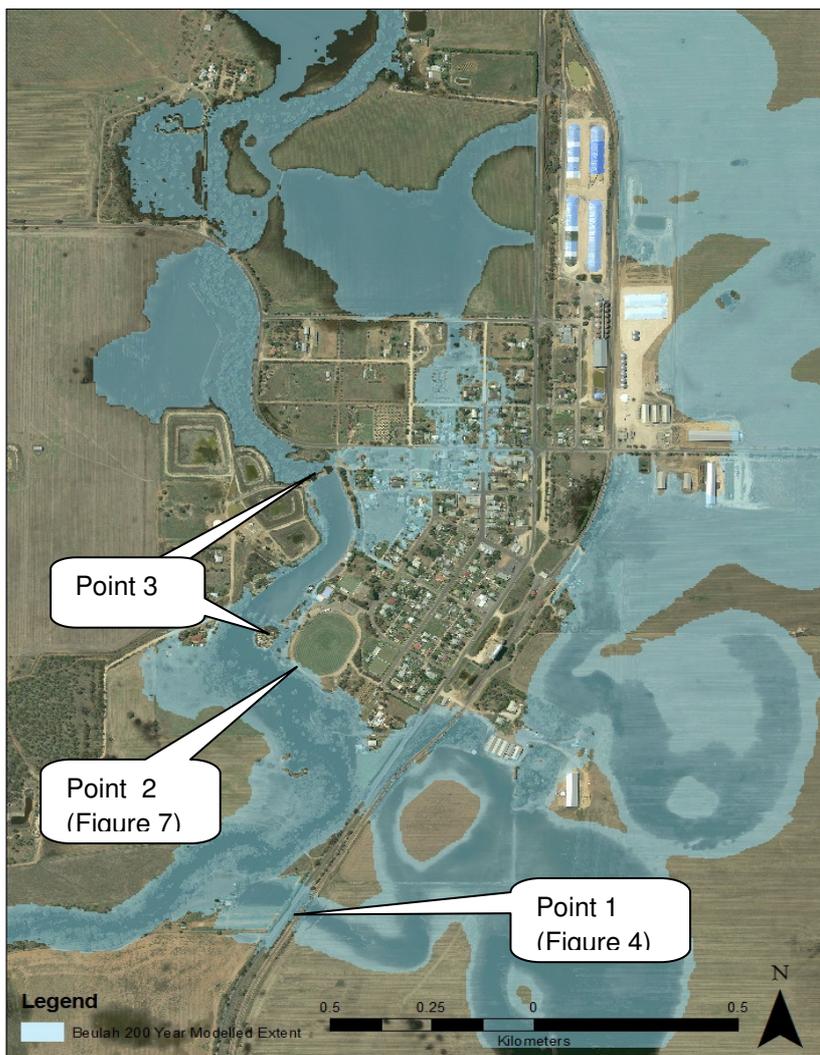
**Map 1: 0.5% Annual Exceedance Probability (AEP) (1 in 200 year) flood map for Beulah with locations of interest identified.**

At Point 1, modelling shows that the blockage of the bridge under the railway line that was undertaken (Figure 8, before authorities requested it be reopened) clearly would have reduced flooding to the east of the bridge but would have exacerbated flooding through the town by up to 0.3m (Map 2).

Point 2 is where earthen embankments were constructed on the south side of Beulah Recreation Reserve (Figure 9). However Map 1 shows that even in a 1 in 200 year flood, it is not at risk as it is an elevated point, thereby wasting resources that could have been effectively used elsewhere.

Pont 3 as in Map 3 shows the impact of increasing the capacity through the town weirs, an effective approach for flood mitigation that ideally should be undertaken during the long intervals between floods but happened during the floods, cutting an important road. The flood of January 2011 did not result in flooding in the township, in part due to mitigation actions (increasing capacity through town weirs).

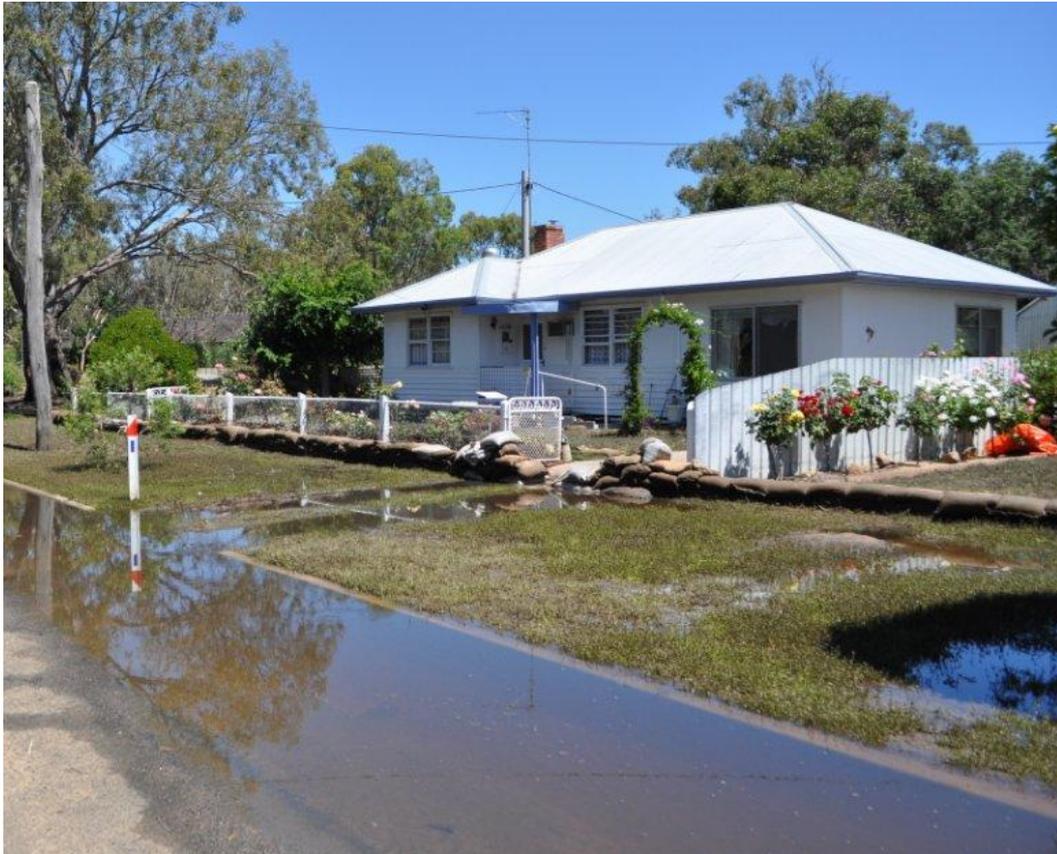
**Figure 10: Sandbagging property boundaries instead of houses such as this one in Dimboola was common and reduced overall floodplain capacity.**

*Lesson 11:* There was a great deal of uncertainty amongst the community with what constitutes appropriate flood defences for their property. Urban residents sandbagged driveways and front yards to prevent floodwaters even entering their property instead of just sandbagging around buildings (Figure 10). This displaced floodwaters elsewhere, creating additional problems for their neighbours. Similarly culverts were blocked in a number of locations, preventing floodwaters spreading and artificially raising local flood levels.

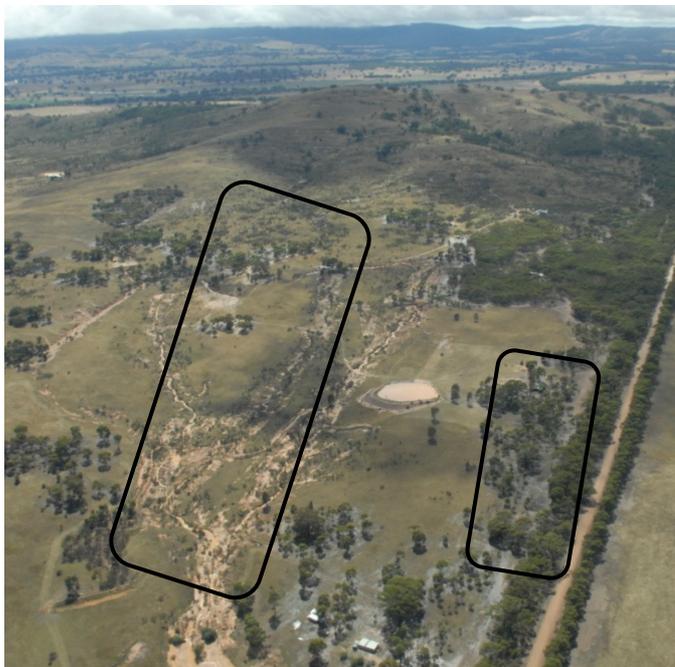
**Figure 12: Flooding near Navarre on 14<sup>th</sup> January 2011, just after heavy rain, note the difference in water on the floodplain in the vegetated areas (right) compared to the eroded gullies (left).**

The experience of January 2011 validated this in terms of observing that the most severe flooding impacts were located immediately downstream of eroded gullies with no vegetation to speak of where water rushed out onto the floodplain immediately downstream (Figure 12). Contrast this with areas that were well vegetated where flood impacts were lessened as high flows continued for a longer period but not at such a large peak volume.
